# The Log of Seawind II Owners

## Nirvana, #84 (K) a Special Seawind II

## **New Dreams, New Owners-- refitting *Flicka*, formerly *Vagabond***

## **Engine Removal & Replacement**

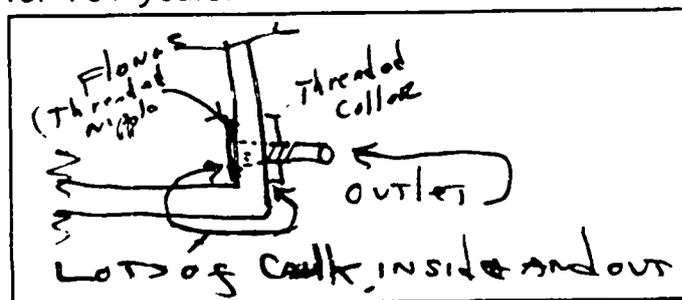
**George and Lynne Lewis, *Origo III*, #93 (K)** The holding tank was bad. It leaked right from the start where the lower hose connected. We found a crack in the tank and the heat-welded fitting was not fitted properly. With two big thru-hull plastic fittings (one male threaded, the other female) and a great gob of Boatlife caulk and a grit your teeth, put your arm and hand into the tank as far as you could reach, it still was smelly and messy attitude, we put the new fitting in, screwed it tight with lots of caulk, and it hasn't leaked for 16+ years.

*George & Lynne Lewis' caulking remedy for holding tank leakage*
